Restored

BY PAUL KELSEY WILLIAMS

A 250-year-old house in Leesburg, Virginia, receives a much needed facelift.

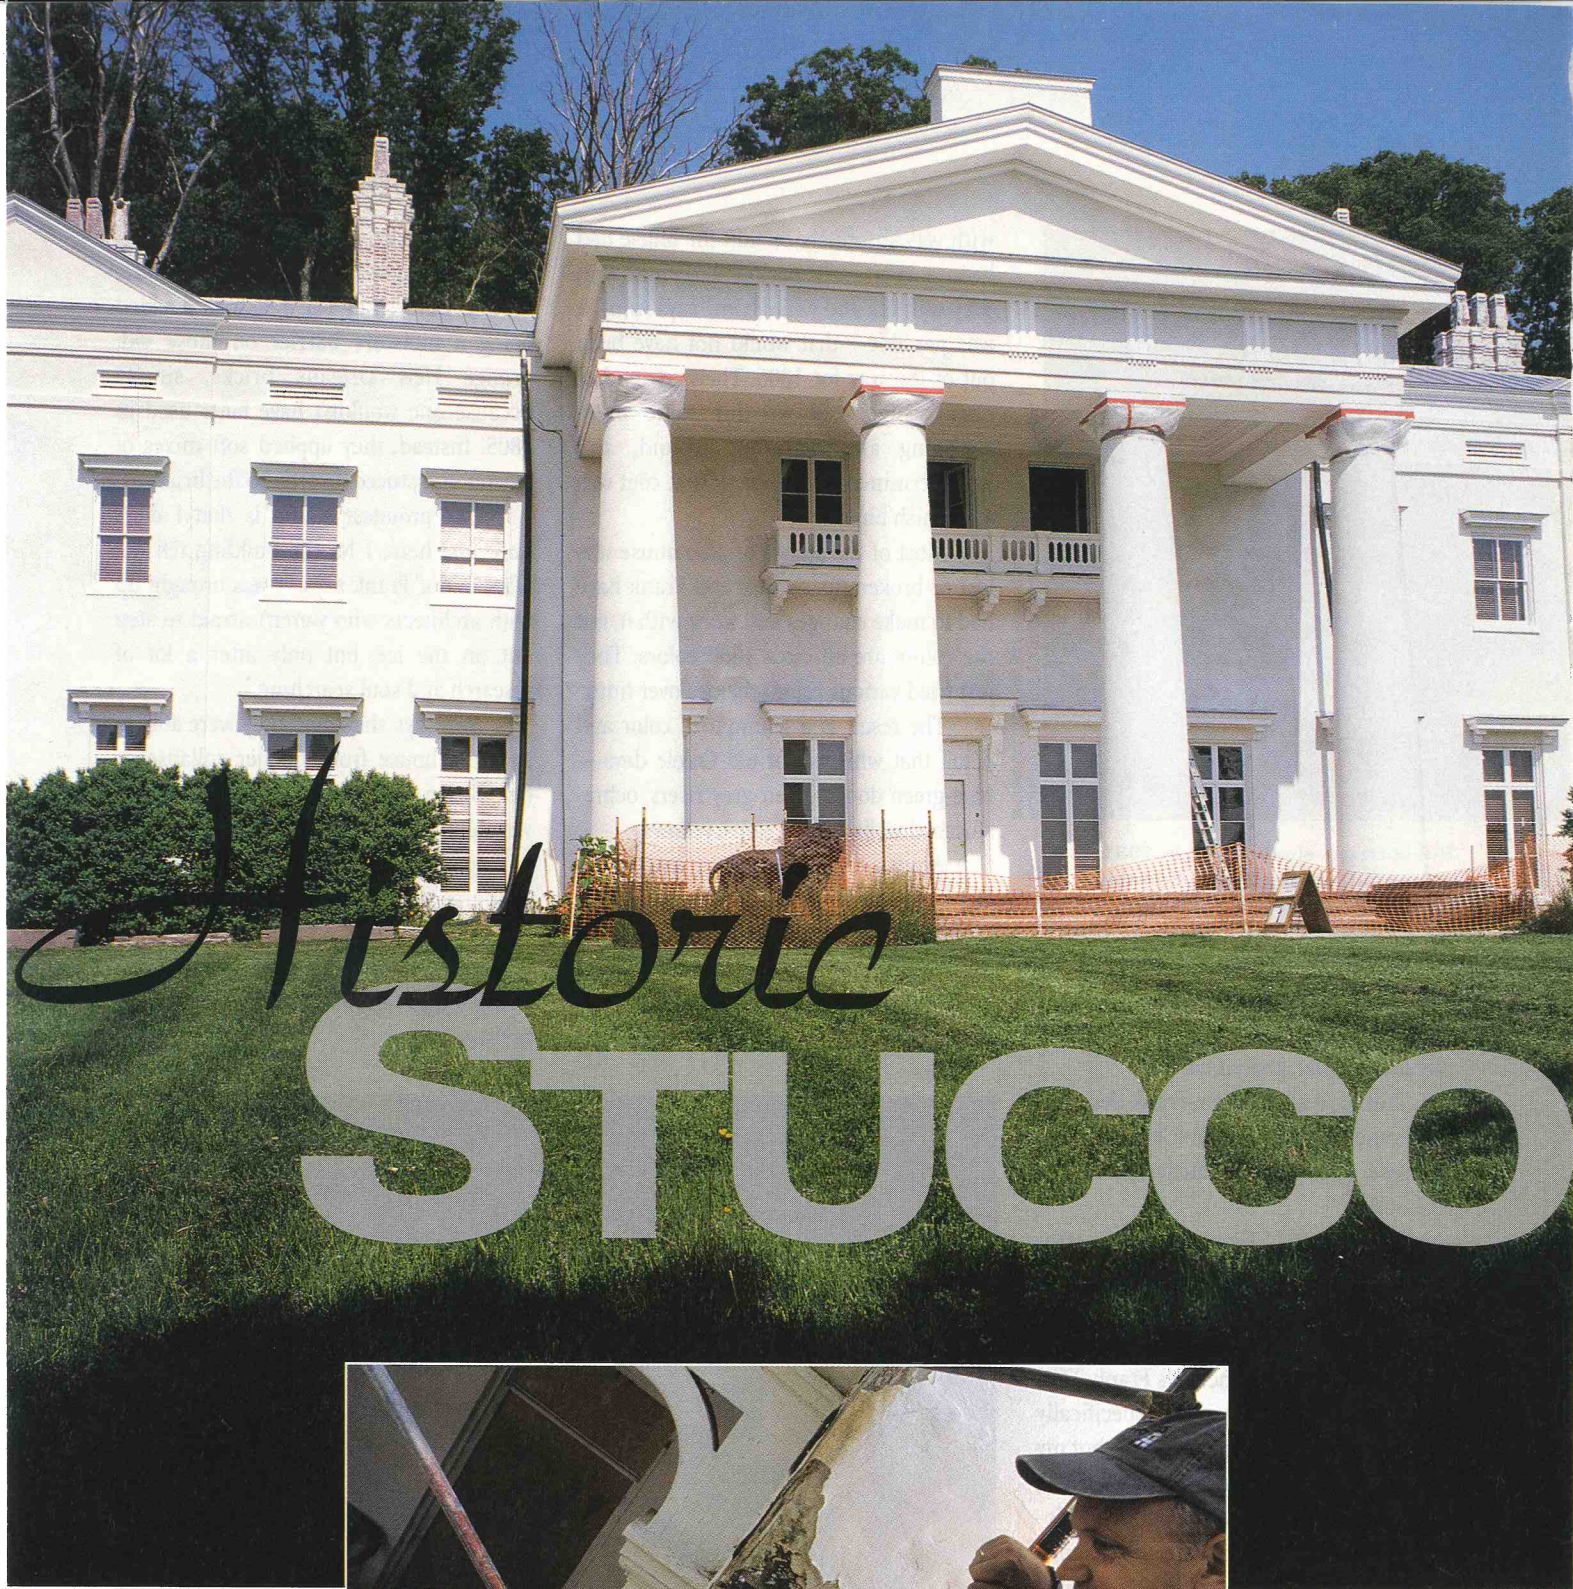
Left: Project architect Doug Gilpin and Rich Baker of Tidewater Preservation discuss the extent of the failed stucco at Morven Park.

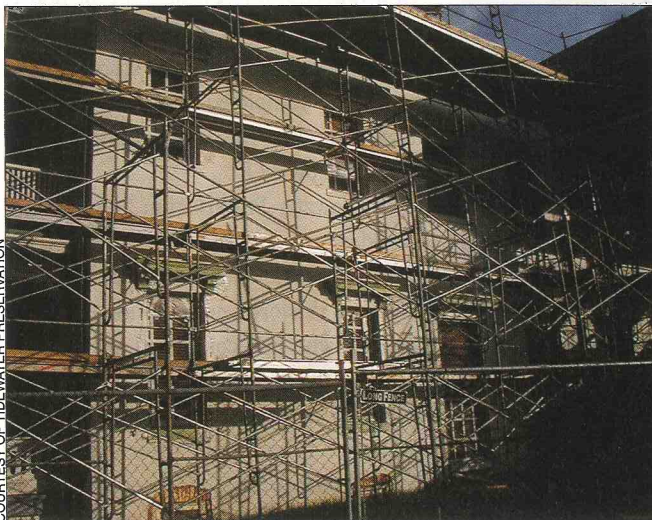
Left: Tidewater Preservation replaced Morven Park's failing stucco. Far left: Today the house museum resembles its 1903 appearance with its new cladding.

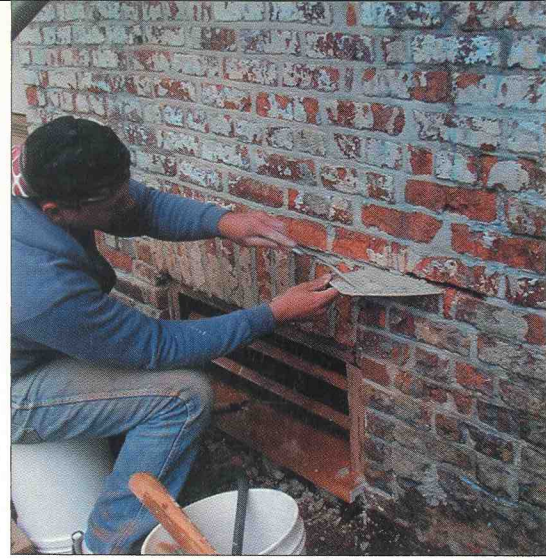
Before the crew could apply the stucco, all the subsurfaces were subject to restoration such as repointing brick.

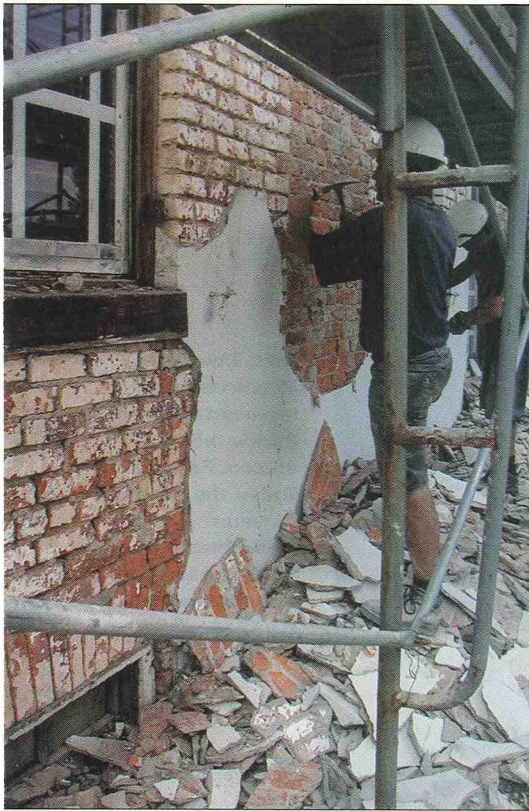
The crew removed the stucco using crowbars. Once the stucco was off, the underlying wood around doors and windows showed signs of rot and had to be replaced.

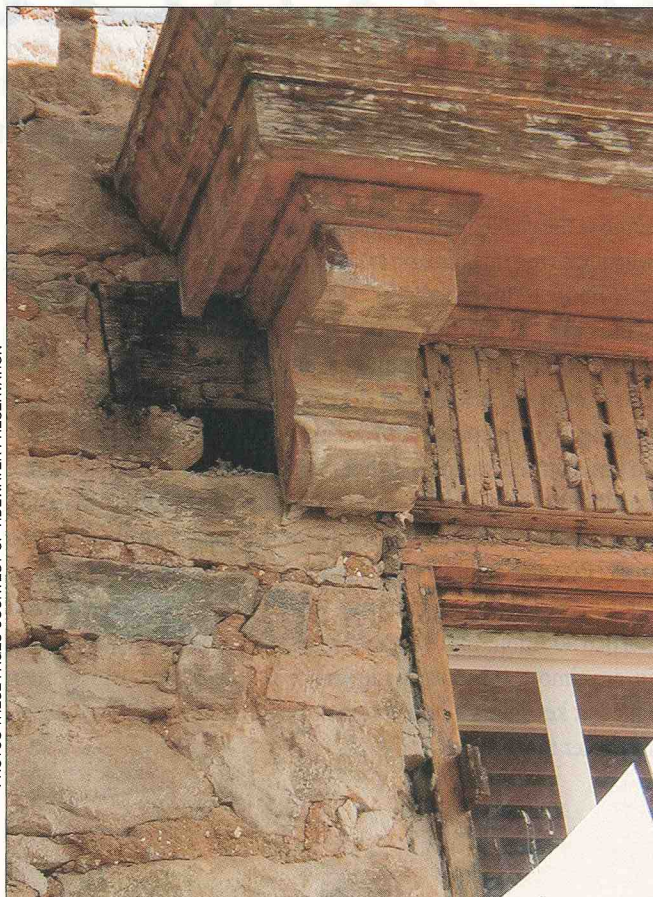
Workers applied the scratch coat directly onto large surfaces of brick and stone.

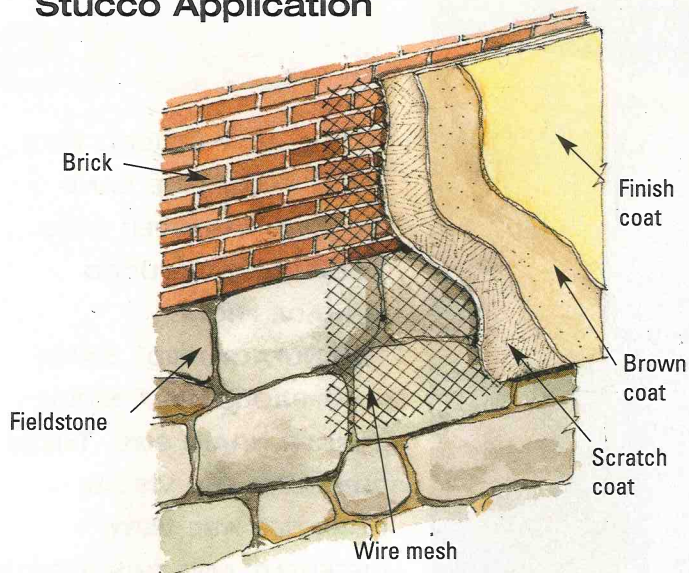
Wire mesh is needed where different materials meet.

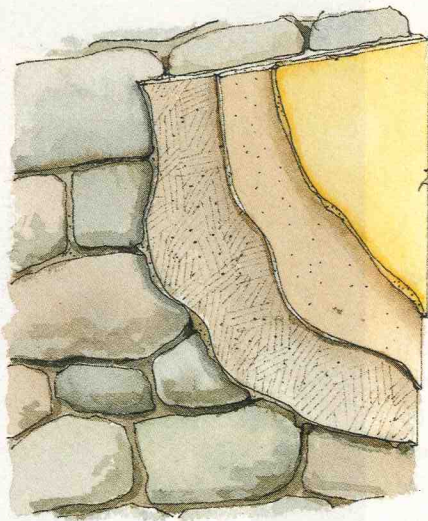
No wire mesh was required when the subsurface was one material.

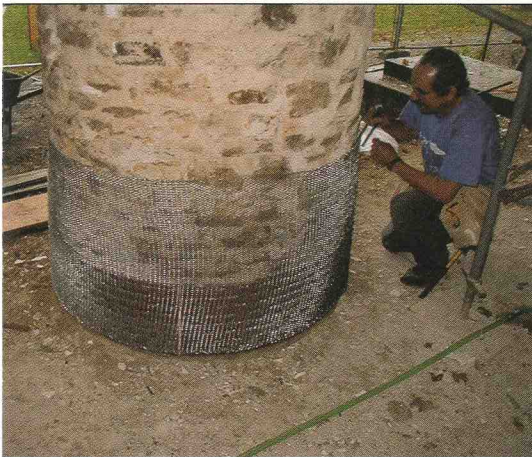
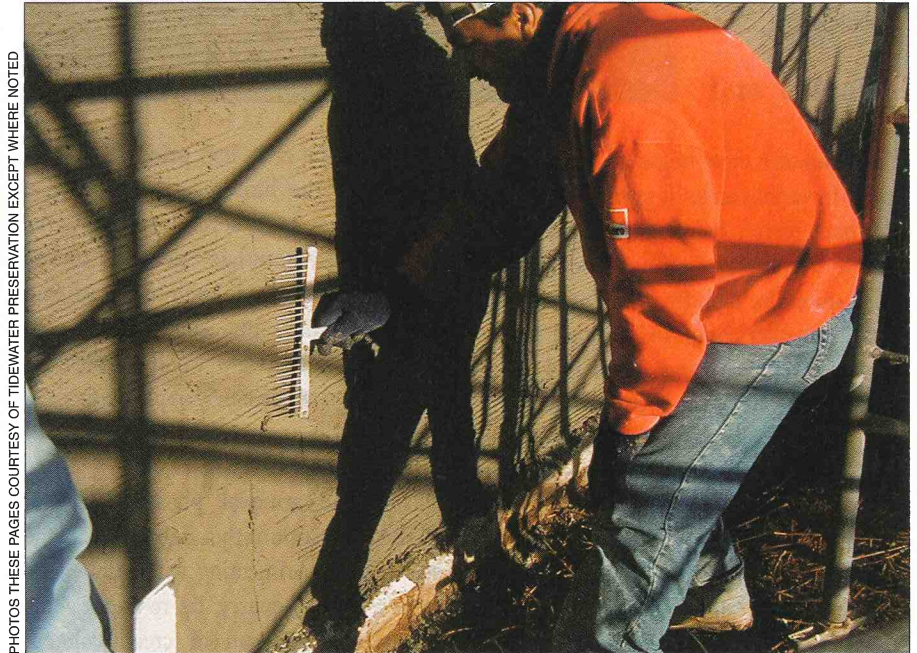
Above: Where two different materials met, wire mesh was used as a base for the stucco. Right: One layer of stucco is raked to create a "key" or rough surface to hold the next.

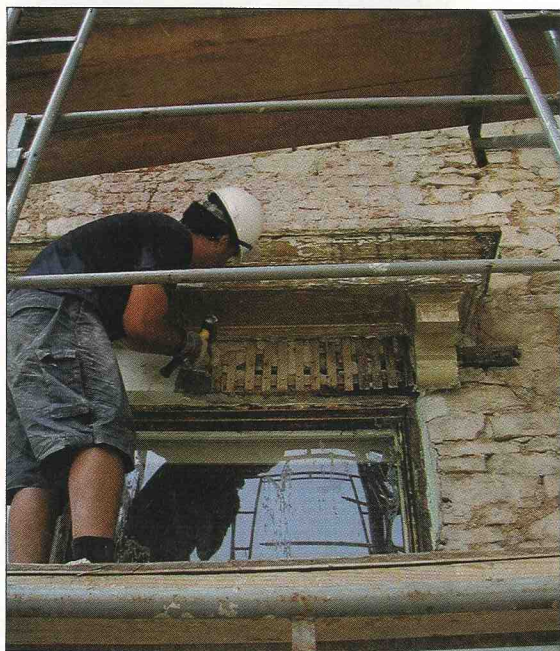
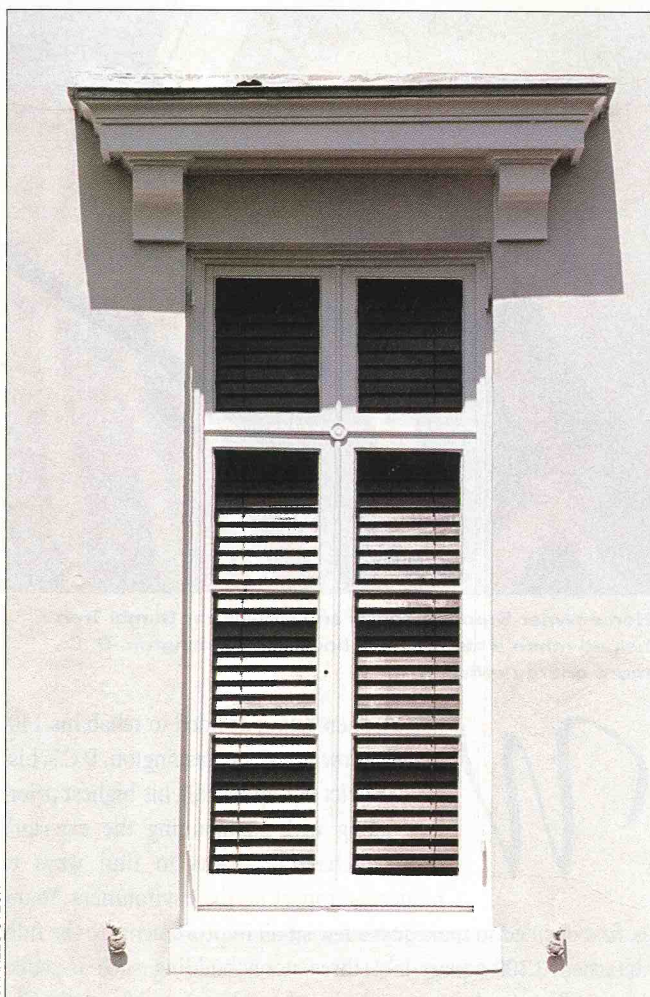
Above: Stucco was removed carefully from this window hood. Right: Today this same window is picture-perfect after its final coat of stucco.
