Restored

BY PAUL KELSEY WILLIAMS

A 250-year-old house in Leesburg, Virginia, receives a much needed facelift.

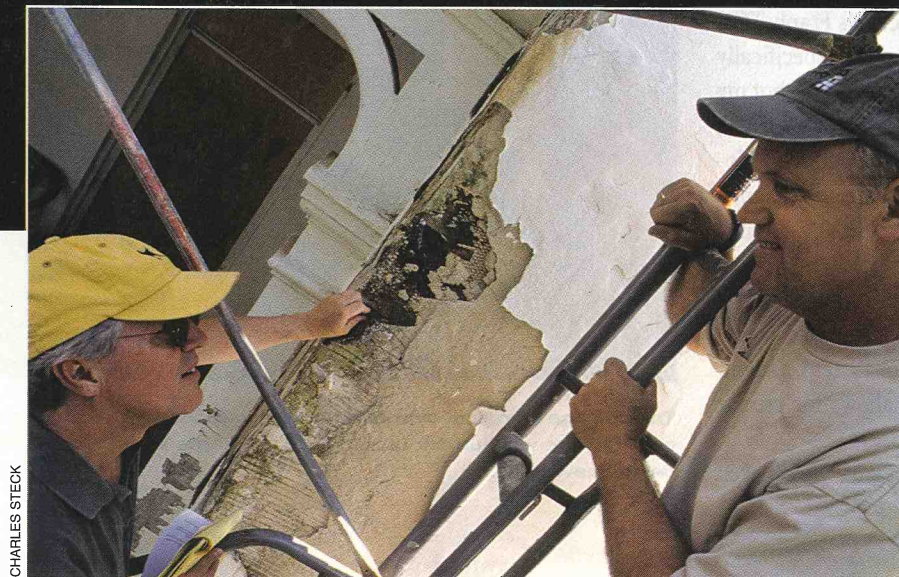
Left: Project architect Doug Gilpin and Rich Baker of Tidewater Preservation discuss the extent of the failed stucco at Morven Park.

The 1903 lime-based stucco had been patched repeatedly with incompatible materials such as portland cement, which promotes cracking and spalling (flaking)

When the staff discovered that the stucco's bond to the subsurface was completely lost in places, they contracted Tidewater Preservation based in nearby Fredericksburg, Virginia, to remove the failing stucco and replicate a new finish similar to the period between 1903 and 1944 when Virginia Governor Westmoreland Davis resided in the house. One of many phases of the overall interior and exterior restoration, the stucco project had to be completed in one summer to avoid freezing mortar if temperatures dipped below 32 F.

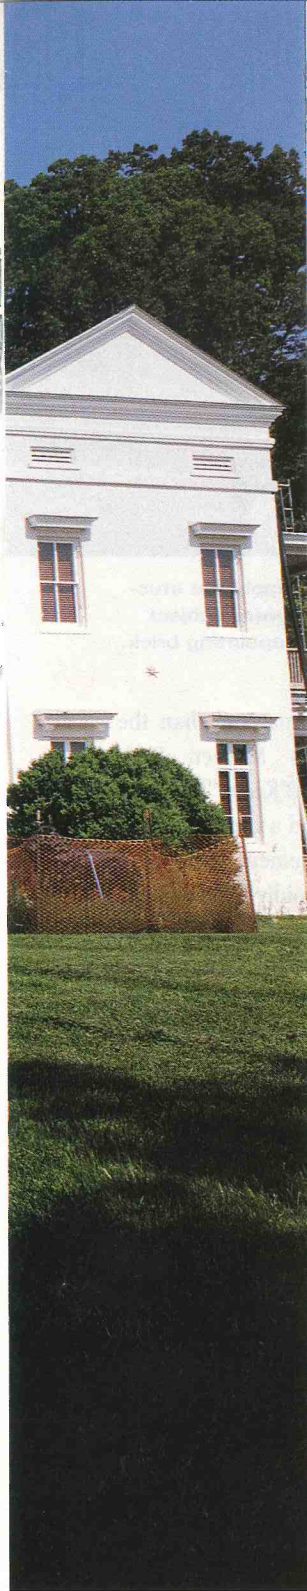
Home to two governors, Morven Park in Leesburg, Virginia, stands as a fascinating example of building accretion. It is composed of remodelings, additions, and expansions from different eras—even the bridging of different houses—all literally joined together over the past 250 years under an even covering of painted and patched stucco. The house evolved from a 1750 fieldstone farmhouse to its current turn-of-the-last-century mansion through seven ambitious building campaigns—one of which was undertaken in 1850 by Maryland Governor Thomas Swann, who added a series of four Italianate towers to an 1825 Greek Revival portico addition. Understandably, such a metamorphosis resulted in an almost constant maintenance of the stucco, which often failed at key joints where different building materials met, allowing water to infiltrate.

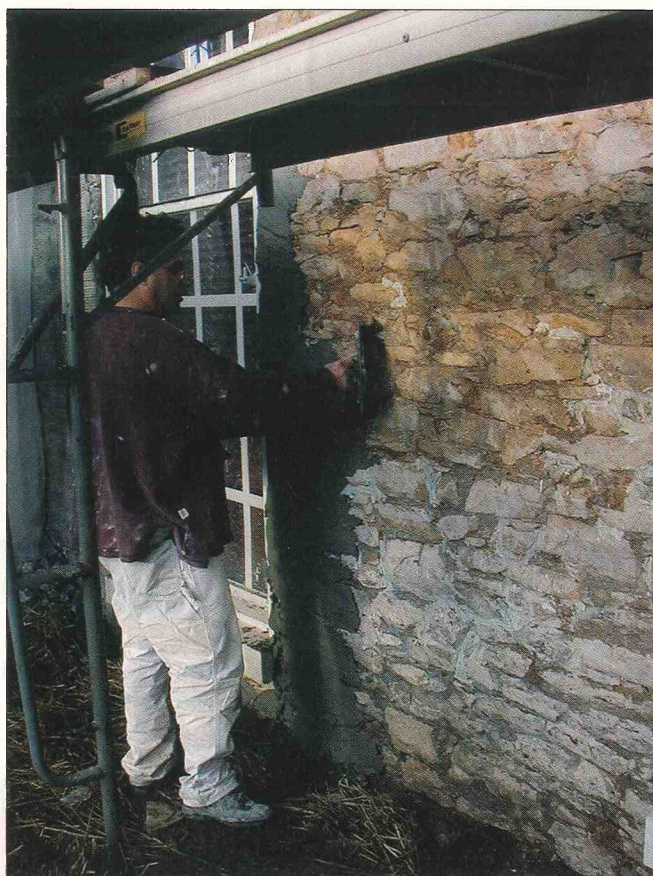
The Tidewater crew began to remove the stucco in various areas by prying with small crowbars placed between the subsurface and the deepest layer of stucco, being careful to minimize damage to the underlying surface whether composed of wood, brick, or stone. Windows and doors had been removed as part of the overall restoration, and were replaced with plywood or Plexiglas to prevent damage. Before workers lowered large pieces of stucco to the ground, they first shielded portions of the façade and wood detailing with plywood to protect it from falling stucco. Stucco that had been applied over chicken wire proved to be the most difficult sections to remove, according to Ecker, because it necessitated cutting old wire while simultaneously removing portions of hard, heavy stucco, a process that often took two workers to perform in concert. Tidewater Preservation carted off tons of stucco that, fortunately, could be disposed of on the 1,200-acre heavily wooded property. (The discarded stucco will later be used as road bedding on the grounds.)

Once the crew had pried all the old stucco off the building—a methodical exercise that took several months—the underlying materials needed to be repaired. This meant repointing brick and stone, replacing rotten wood, and, in some cases, fabricating new wood supports in anticipation of the newly applied stucco.
